# A JENBACHER CASE STUDY

Repair Of Bearing Caps ,Linear landings  
& Oil Gallery

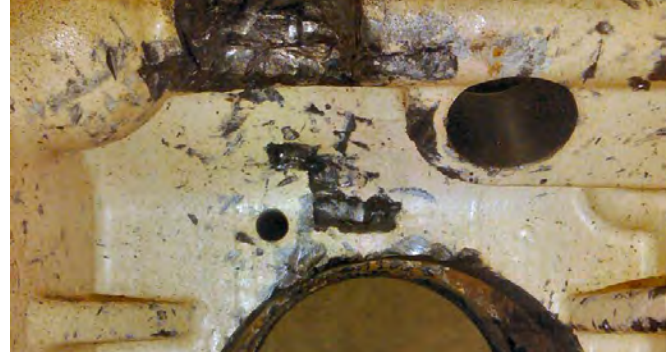
Damaged Oil Gallery

The oil gallery had been crushed and cracked which would require an extensive repair. The lower liner land area had large areas of impact damage and would require boring oversize and sleeving. (see opposite). The caps were scored and closed in.

We ground out the oil gallery to remove the damaged section. We then reamed the bore to give a good size and finish to allow the fitting of a thin wall tube. After manufacturing a thin wall tube in our workshops (allowing for a slight interference fit), we pressed it into position and secured it with Loctite adhesive. The surrounding area was then built up with liquid metal to match the existing profile.

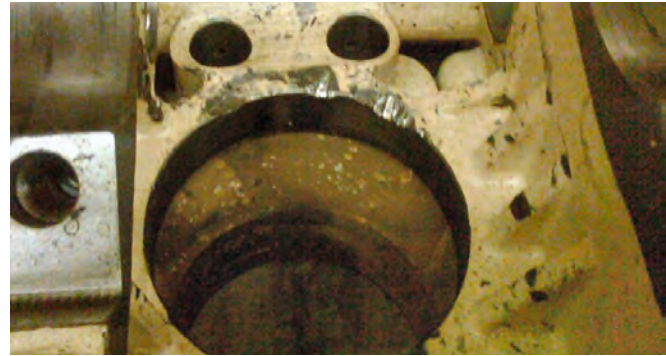
Damaged Lower Liner Landing

We mounted a line boring machine (in this case a Climax BB5000) in the top liner landing using a special precision mount to allow us to reference the undamaged bore. We then bored the landing oversize and fitted a precision sleeve (grub screwed into position).

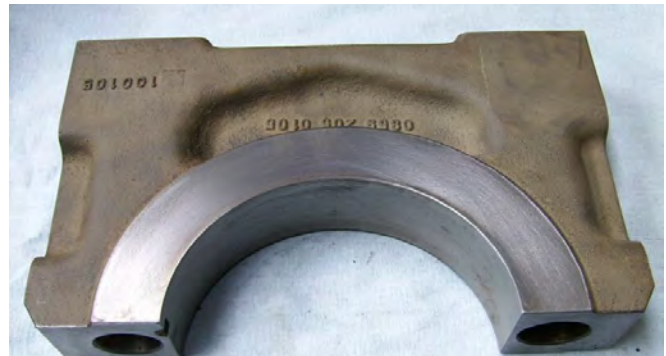
Refurbished Jenbacher Cap

The caps were welded, stress relieved, machined and re-bored back to standard size.

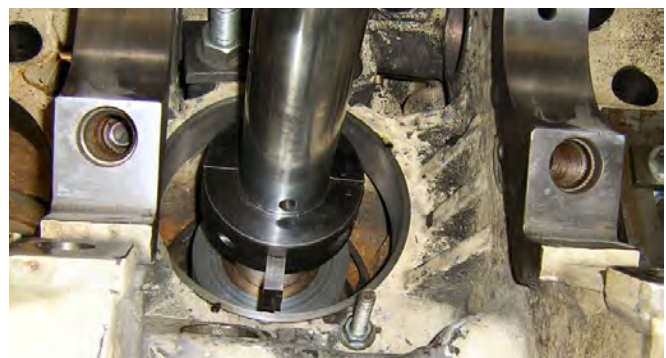
Repaired Landing & Oil Gallery
