# CASE STUDY- METAL STITCHING

## Background To The Metal Stitching Repair

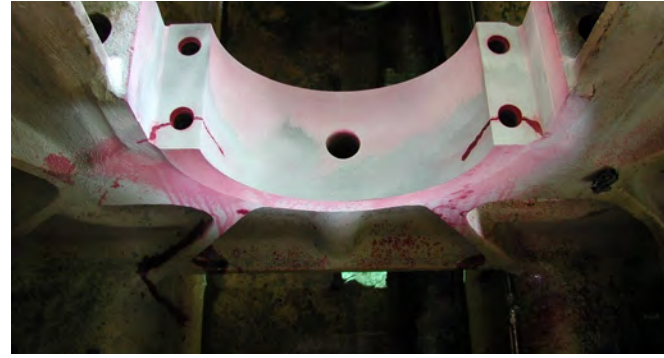
NDT checks showed extensive cracks radiating from the stud holes in two positions. Localised metal stitching would obviously have been of insufficient strength. We suggested that "in our experience" the best repair method would be to cut out the whole of the main bearing pocket and to metal stitch in a new one.

Damaged Main Bearing Cap Stud Hole

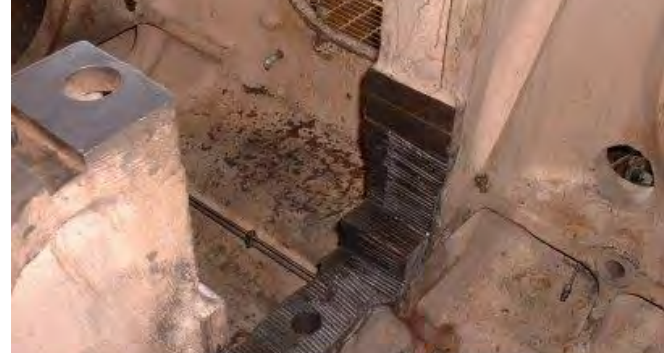
Main Bearing Pocket Section Removed

We drilled a series of holes around the damaged pocket conforming to the shape of the new insert. We removed the damaged portion, then carefully positioned, restrained and metal stitched the new insert into place. (We manufactured the insert in our workshops in the UK).

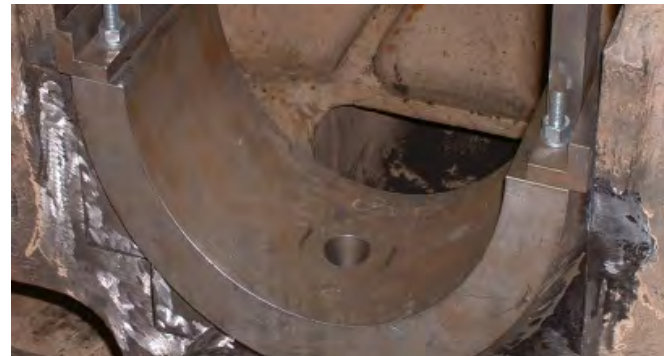
Inserting The New Pocket

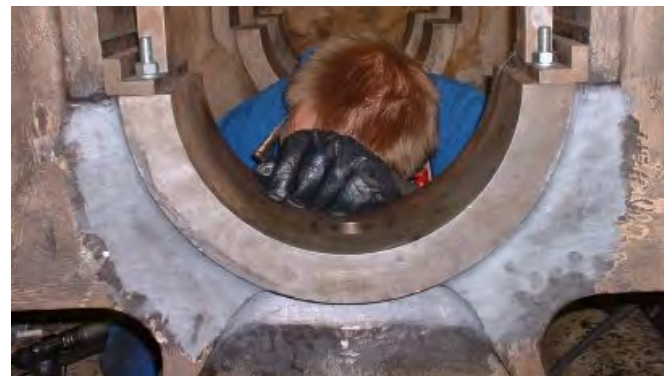
Finished Repair After Hand Dressing

After stitching we carefully hand ground and dressed the surrounding areas to blend in seamlessly with the original.
