CASE STUDY- TAIL SHAFT MACHINING

Background To The Tailshaft Repair

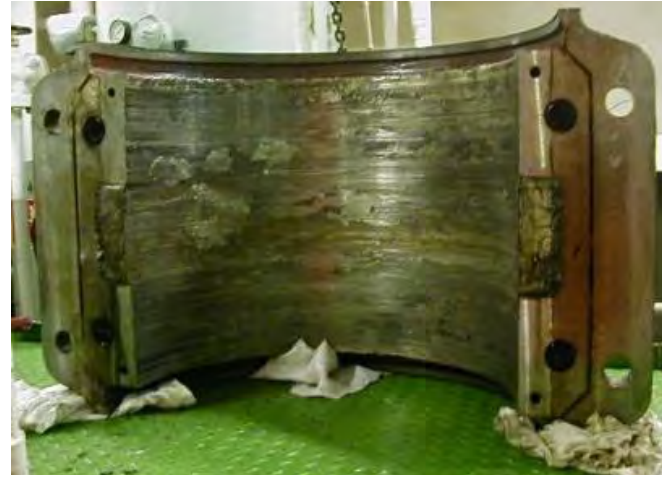
The white metal bearing had failed leading to pickup and areas of deep scoring. Micrometer readings showed an undamaged area at each end of the journal. These proved suitable for use as datums for the orbital machining and polishing operation.

Damaged White Metal Bearing

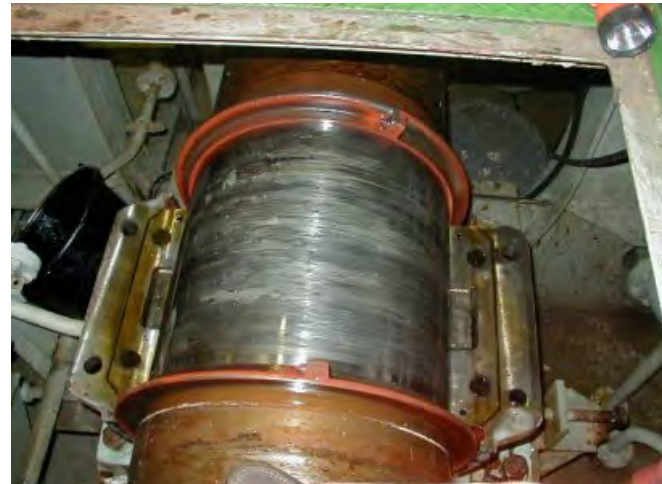
The Moscow had a failure on its 505mm Ø (400mm long) tailshaft pedestal journal. Nicol & Andrew were called in to re-machine the damaged journal in-situ, using specialised orbital equipment.

Damaged 505mm Ø Tailshaft Journal

Carry out in-situ machining and polishing to remove all signs of damage, whilst maintaining concentricity and roundness within OEM tolerances. Obtain undersize bearings to suit the repaired journal.
